**Gypsum in Minoan Architecture: Exploitation,
Utilisation and Weathering of a Prestige Stone**

Vol.I: Text

STEPHANIA CHLOUVERAKI

Institute of Archaeology

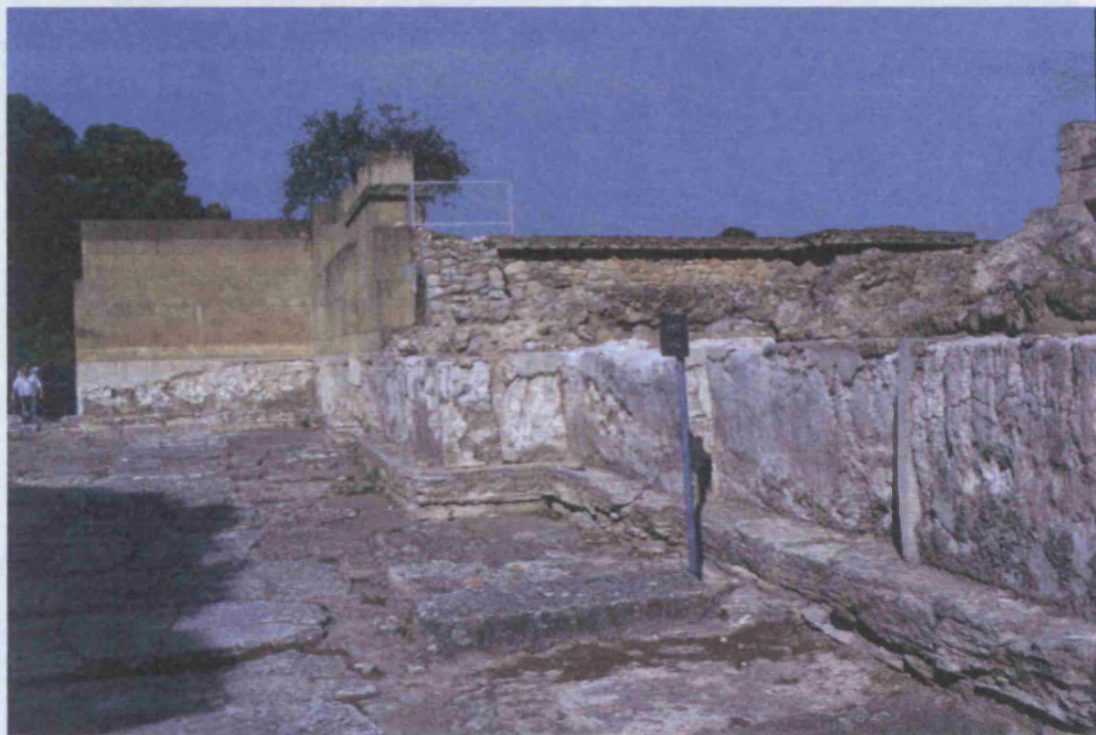
Fig. 5.2: the great gypsum orthostates of the West Façade at the palace of Knossos.

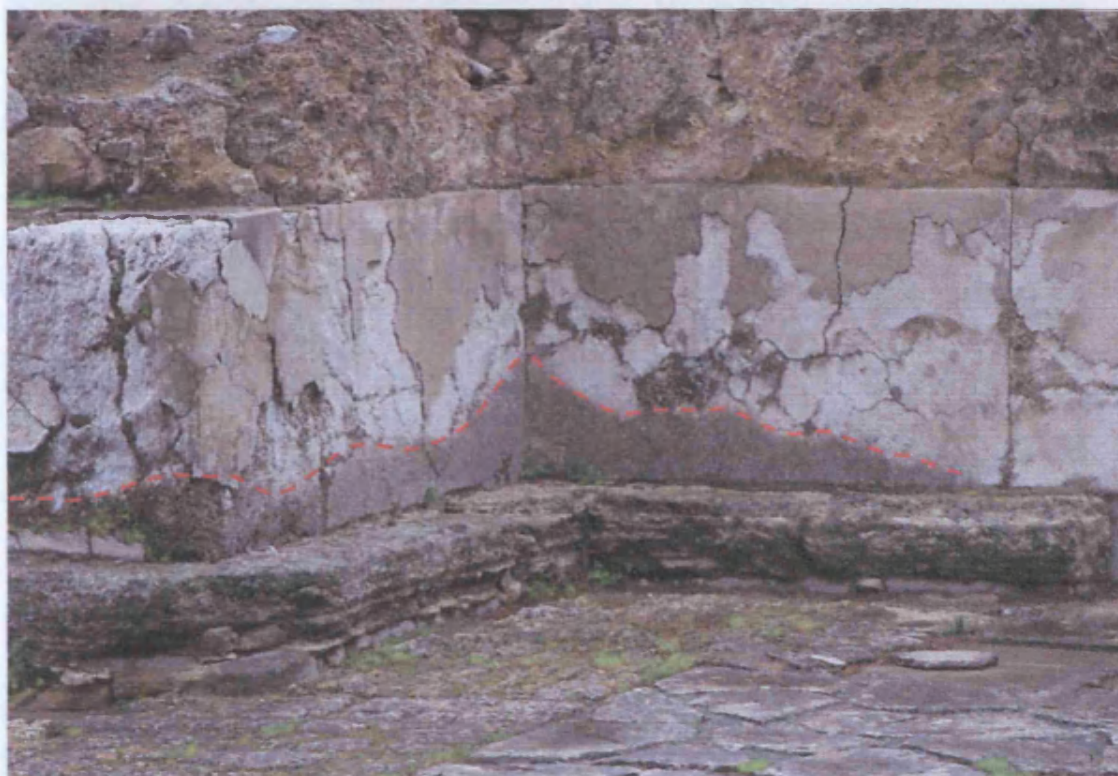
Fig. 5.4: transition line of burned/unburned selenite orthostate of the West Façade at the Palace of Knossos

Fig. 5.4: transition line of burned unburned selenite orthostate of the West Façade at the Palace of Knossos

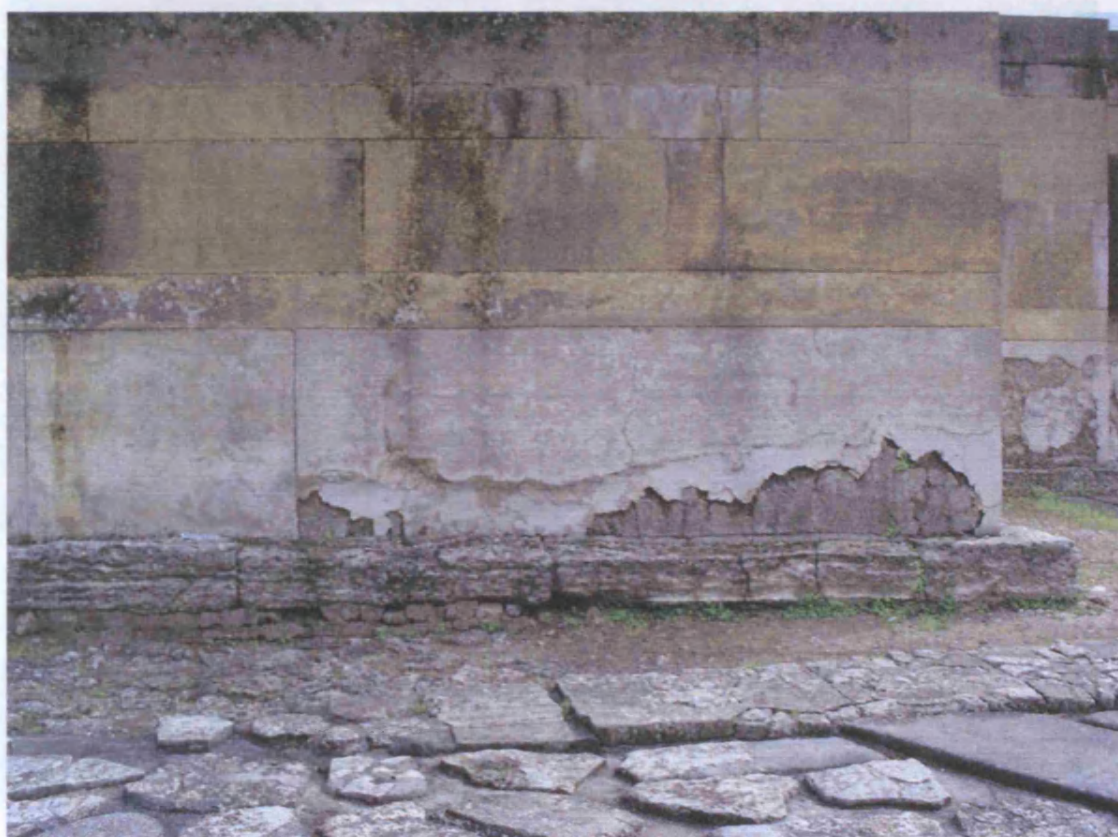
Fig. 5.5: selenite orthostate unaffected by fire, at the north end of the façade

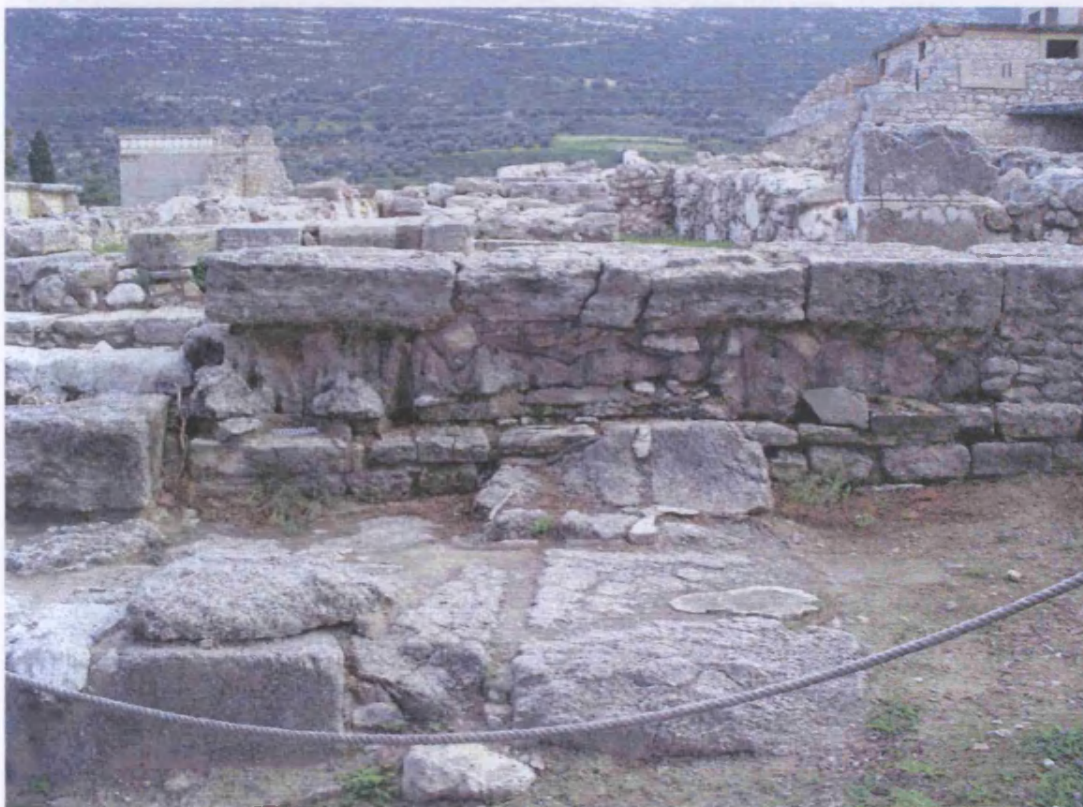
Fig. 5.6: unaffected selenite blocks under and in front of the *krepidoma* of the West Facade

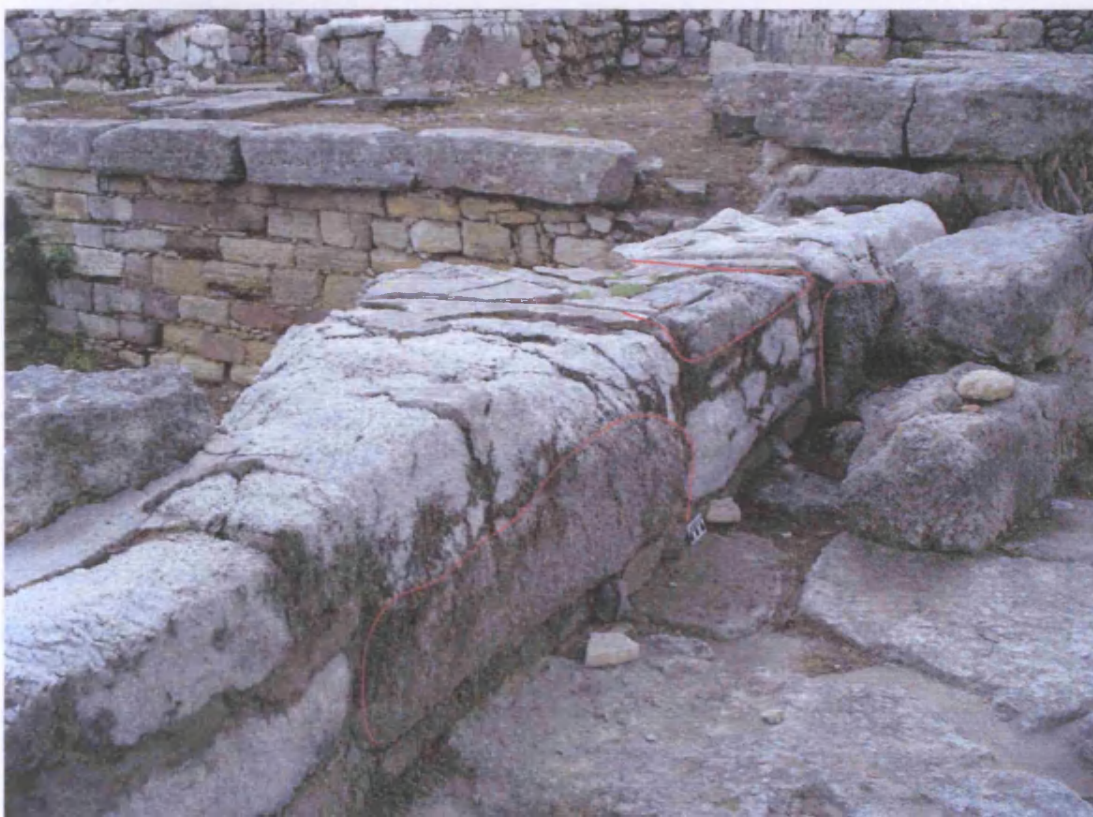
Fig. 5.7: Fire marks on the selenite blocks north of the *krepidoma* of the West Facade

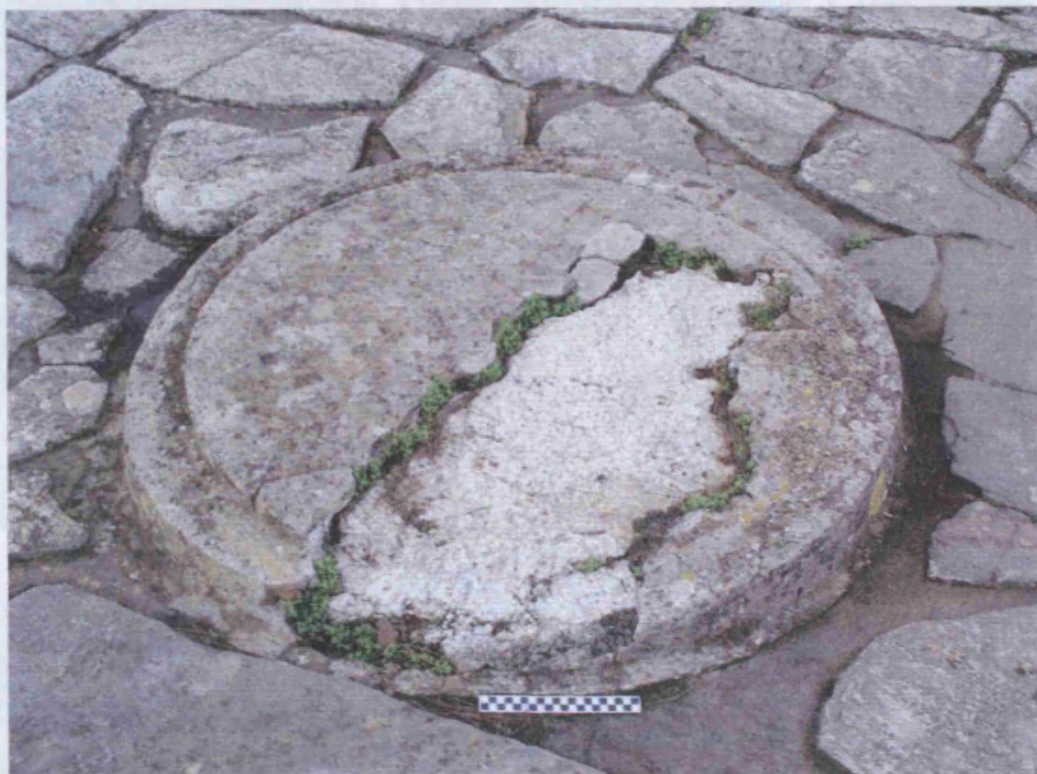
Fig. 5.8: column base of West Porch *KN 4*

The roof of the porch was supported by a single wooden column set on a round selenite base (*KN4*) about 1.35m in diameter of which almost 40% is preserved. The selenite is affected by fire except for part of its outer surface that can be seen on the east side, (Fig.5.8-5.9) where the restoration mortar has been removed. A course of selenite orthostates that continues the West Façade formed part of the east wall, while on the west wall, also set on a projecting course of limestone blocks, are another two orthostates (*KN1-2*). They are mostly unaffected by fire and although quite weathered and dull, they show the original crystallographic characteristics of the material and are very close to the original appearance of the orthostates of the façade (Fig.5.10, Appendix 1: Plan 1, Drawing 1).

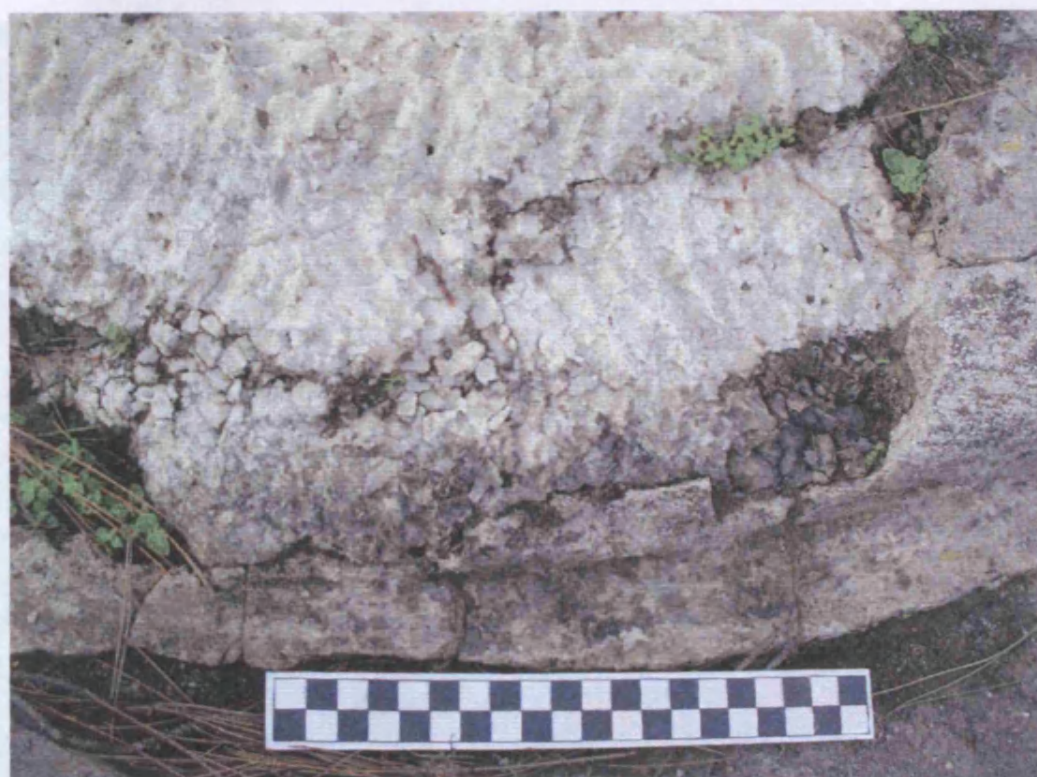
Fig. 5.9: unaffected part of column base *KN4*

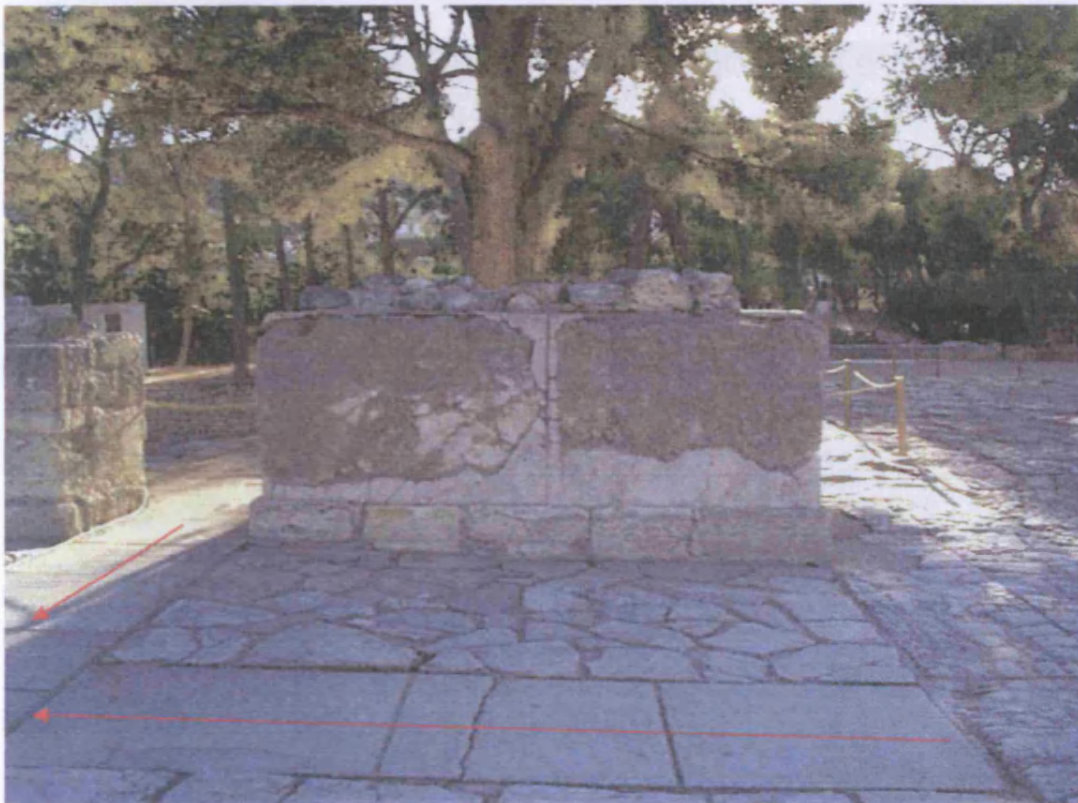
Fig. 5.10: restored gypsum walkways and selenite orthostates of the west wall of the West Porch at the Palace of Knossos

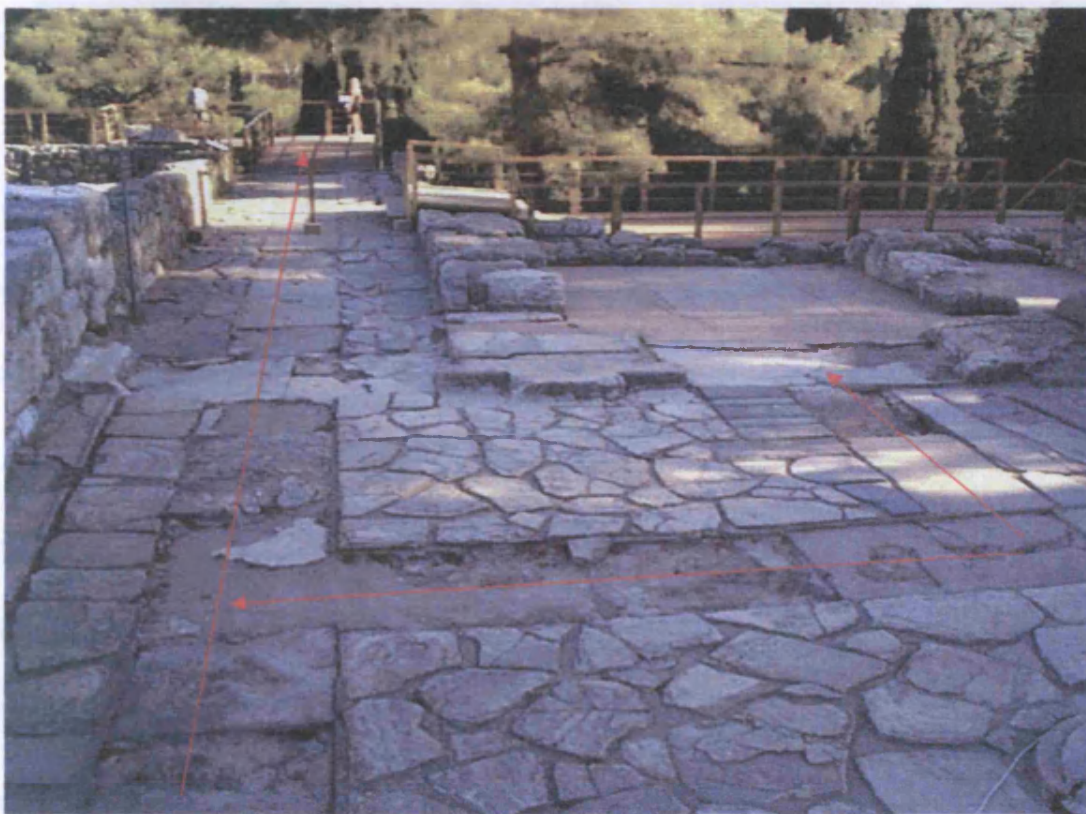
Fig. 5.11: the gypsum walkways of the West Porch and the Corridor of the Procession

Gypsum walkways under the sheltered porch lead the visitor to the entrance of the **‘Reception Area’** (12), the **‘Warder’s Lodge’** (13) and the **‘Corridor of the Procession Fresco’** that leads to the interior of the palace (Fig.5.11). The large doorjamb bases and the threshold of the entrance are made of banded selenite that is placed so that the direction of the crystal growth is horizontal. The westernmost doorjamb base (*KN6*) shows clearly the transition of burned/unburned material and is perhaps the clearest example in the entire palace that illustrates the effects of fire on selenite. The wooden door frame that stood on the base left a clear white mark on the selenite surface. It can be seen as an L-shaped white area that corresponds to the part that was in contact with the burning wood. The rest of the base that was built over with non flammable materials, presumably a rubble construction, remained unaffected by fire and preserves its initial crystallographic characteristics (Fig.5.12). The selenite ashlar blocks of the wall that divides room 12 and 13 (*KN40, 41*) show similar fire marks with a characteristic alteration of the outer surface that was exposed to the fire whilst the

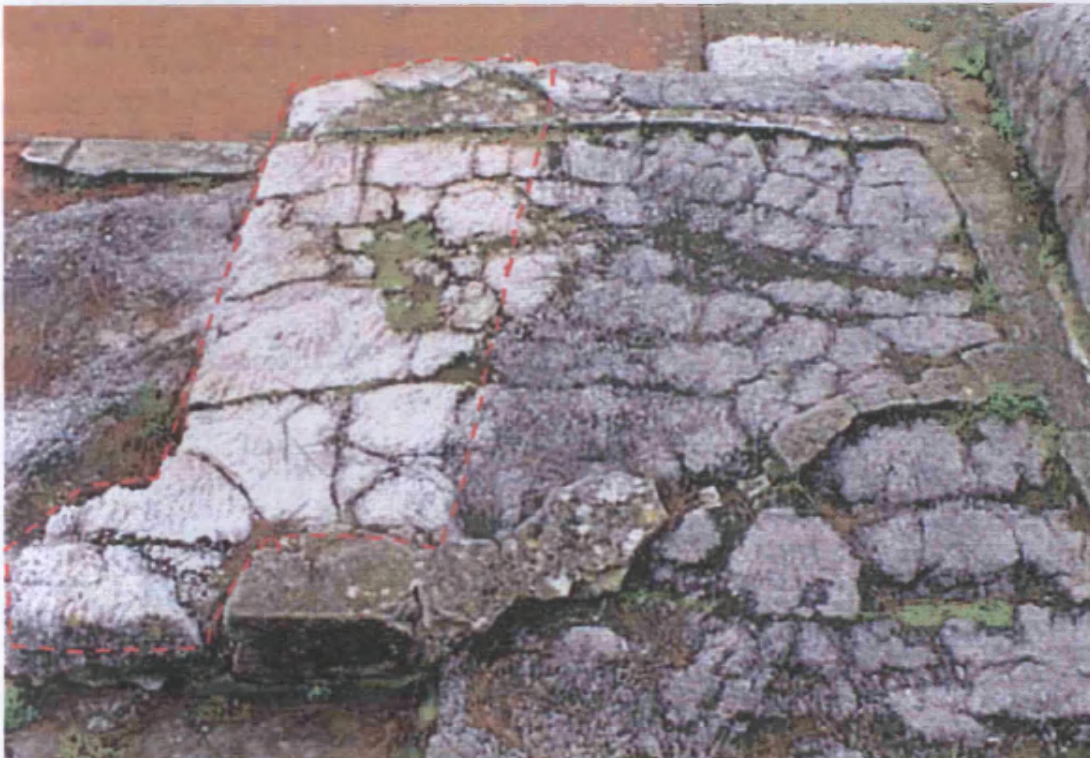
Fig. 5.12: the wooden frame of the door is clearly marked by the whitening of the selenite on the partly burned doorjamb base (KN 6) at the entrance of the West Porch

selenite on the partly burned doorjamb base (KN 6) at the entrance of the West Porch

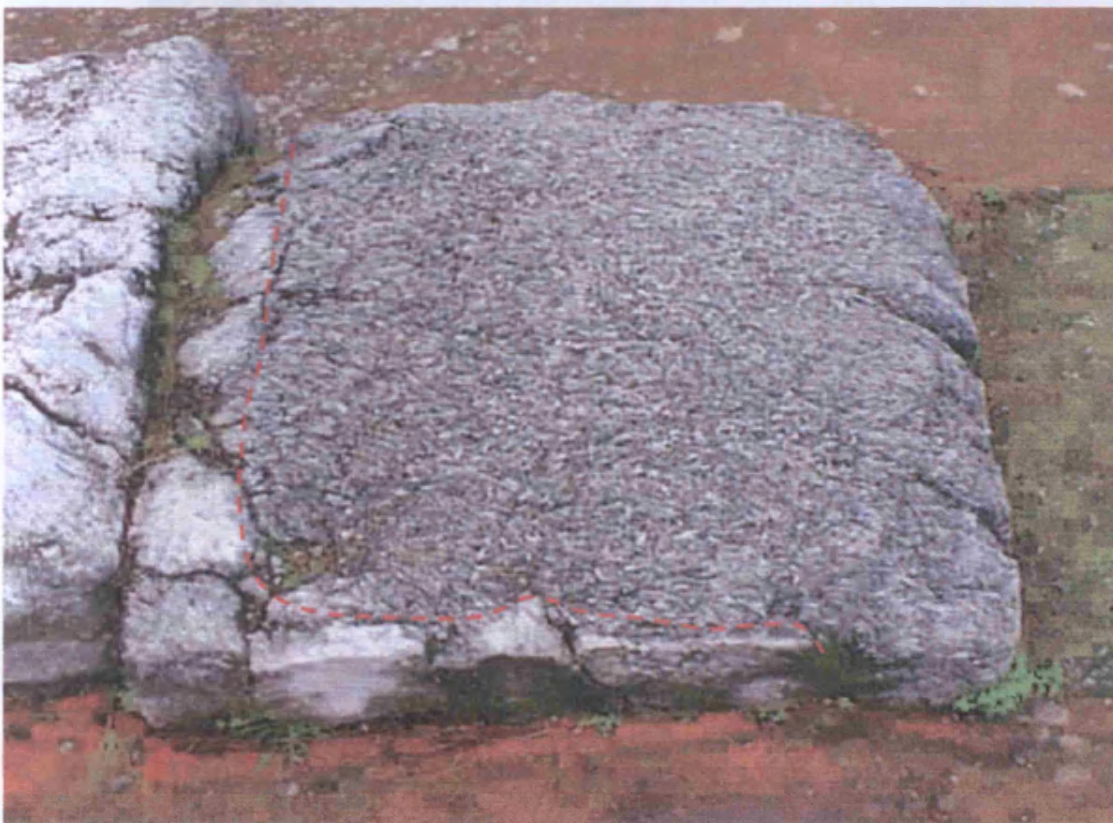
Fig. 5.13: alteration of the outer surface of selenite ashlar block (KN 40) due to fire

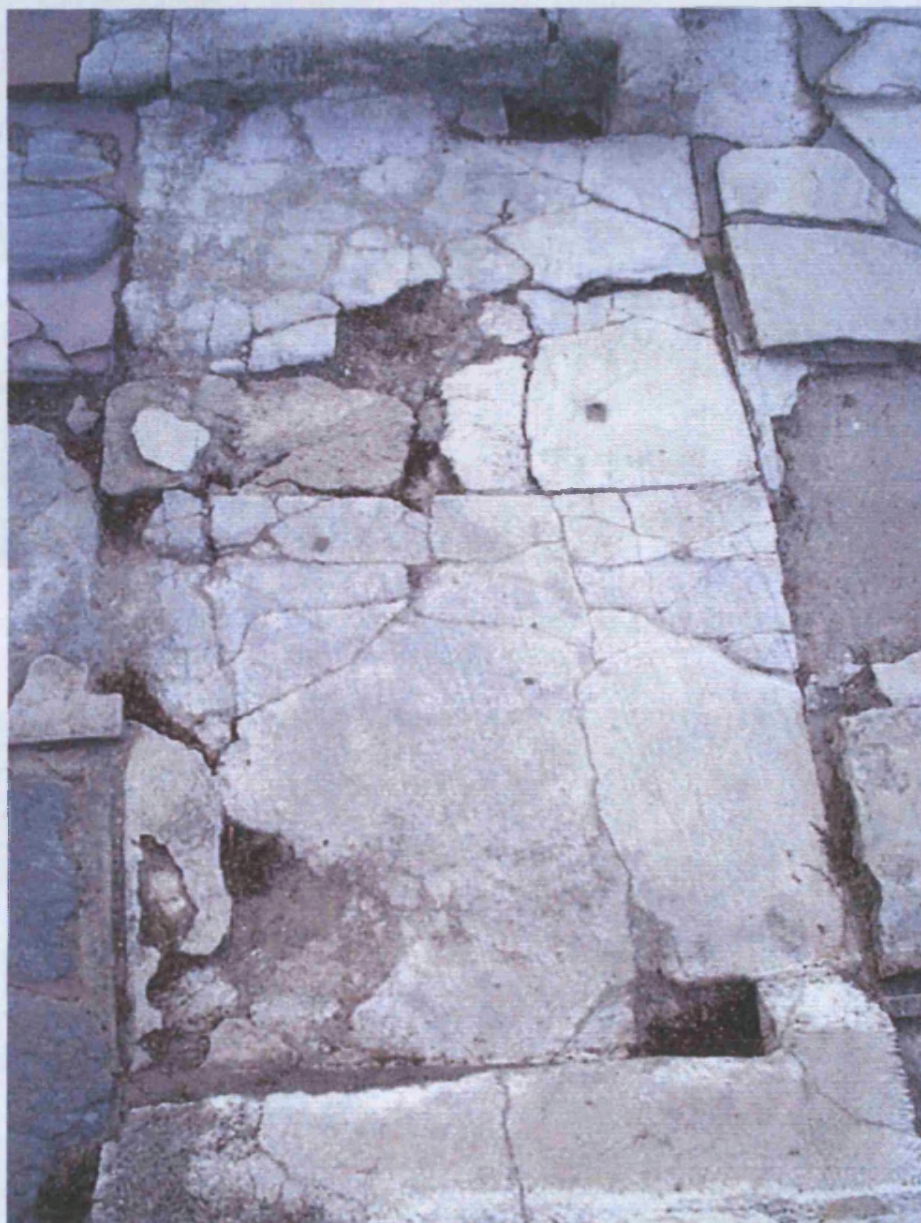
Fig. 5.14: threshold slabs of banded selenite at the West Porch entrance to the Corridor of the Procession Fresco

The slabs that paved the threshold of the entrance are also made of banded selenite that is placed in the same direction as the above mentioned doorjamb base, in a manner that displays again the most reflective face of the stone that is parallel to the direction of the crystal growth (Fig.5.14). Although the original slabs of the threshold are preserved *in situ*, only a few traces of gypsum are preserved at the walk ways of the West Porch and of the **‘Corridor of the Procession Fresco’**. Most of them are restored in concrete and therefore it is not possible to describe the varieties with certainty. However, the few remaining traces of gypsum that are preserved (fragments of two slabs: KN18 and KN36) consist of burnt selenite with an average crystal size of 1,5cm. They are similar to the slabs of the threshold and display the same reflective surface. A third slab that is preserved and visible at the porch (KN38) made of ‘nodular and lenticular’ gypsum was almost certainly placed here in the course of some restoration campaign, perhaps by N. Platon, as it resembles the material that is used for the replacement of the slabs in the main corridor of the West Magazines in the Lobby of the Stone Seat and the Ante-Room of the Throne (Fig.5.15).

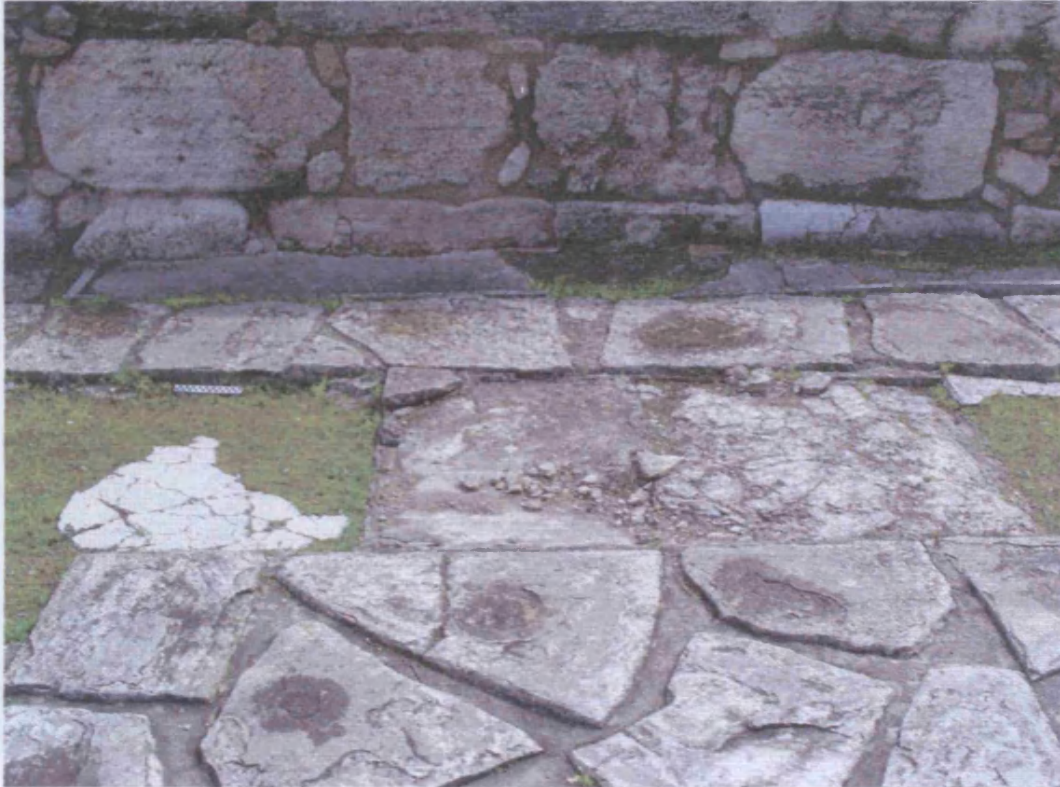
Fig. 5.15: original (left *KN36*) and modern (right *KN38*) gypsum slabs at the beginning of the Corridor of the Procession Fresco

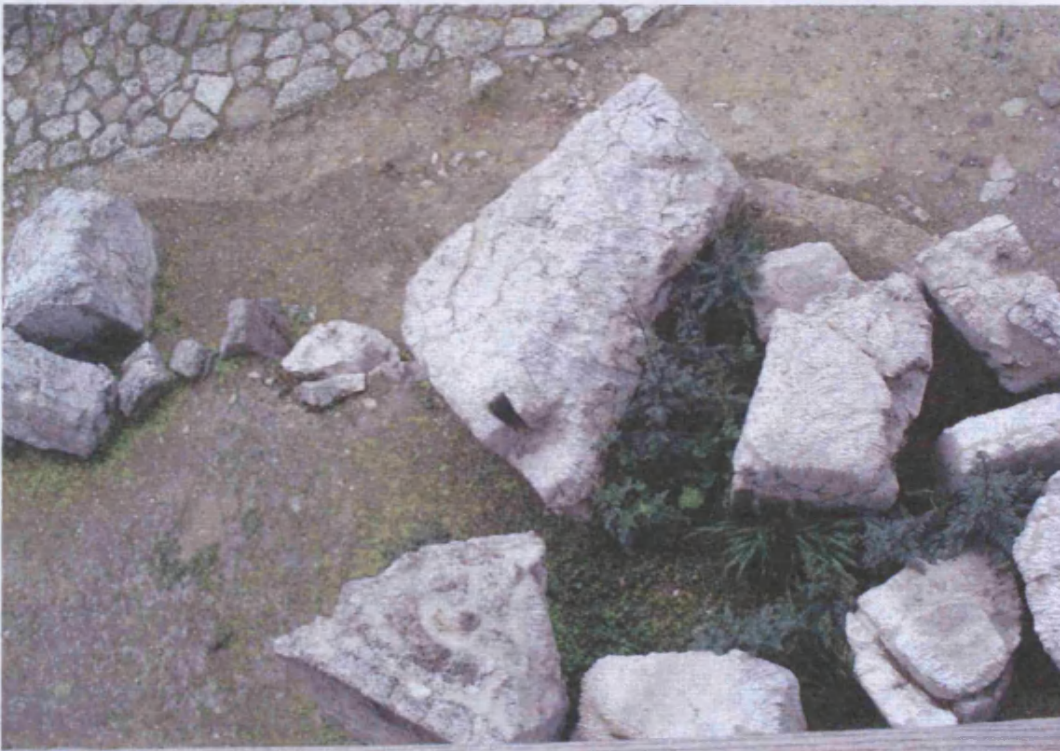
Fig. 5.16: abandoned blocks most probably from the collapsed south-west corner of the building

Below the present wooden walkways at the **south-west corner** of the building, are several abandoned selenite blocks that most probably belonged to the collapsed south west corner of palace (KV68-81, Appendix 1: Plan 2, Drawing 2-3). They are all made of selenite and some of them have been partly burned showing clear transitions of material affected/unaffected by fire (Fig.5.16). The crystallographic characteristics are very similar to those of the selenite orthostates of the West Façade. Furthermore, the same technique was used in quarrying and cutting of these blocks that always display on their vertical surfaces the long side of the crystals. As explained before this means that the horizontal surface of the blocks is parallel to the stratification of the bedding while the vertical side is parallel to the direction of crystal growth. These blocks could have

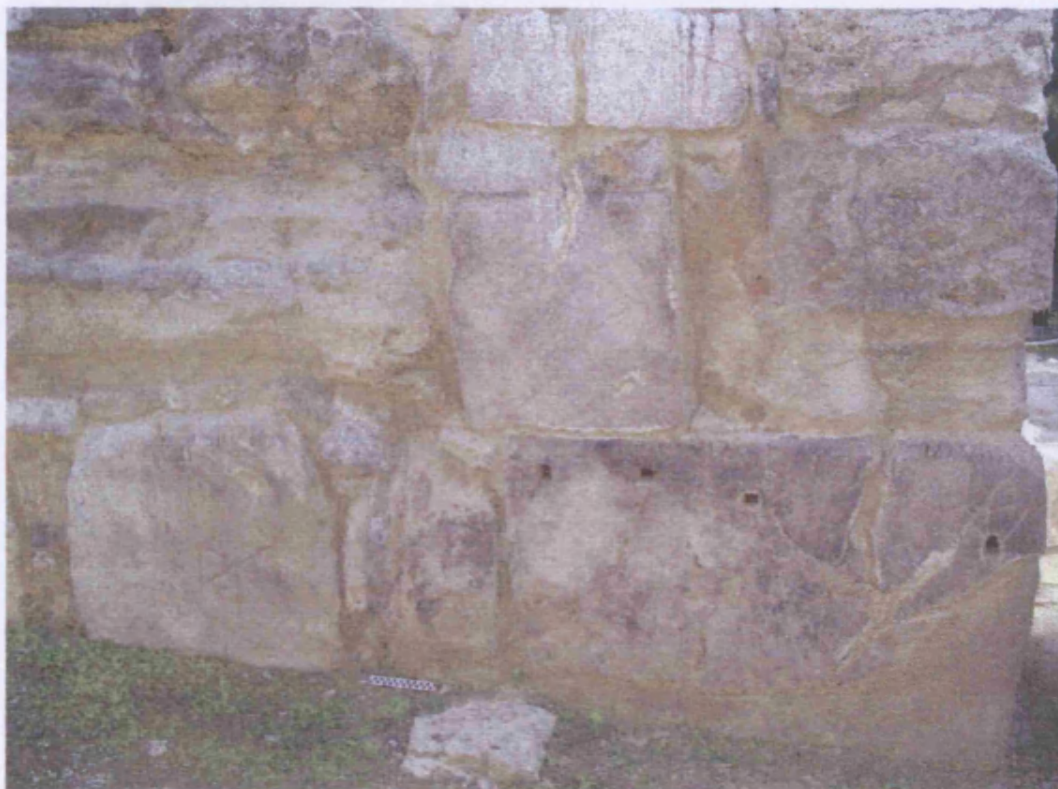
Fig. 5.17: gypsum blocks in secondary use, built in the south wall of the South Terrace Basements (notice mortises and double axe mason's mark)

Several selenite blocks (*KN81-90*) are also in secondary use built in the south wall of the **‘Magazine of the Inscribed Vase’ (3)** below the south west corner of the palace. Reused selenite blocks are also found in the room under the **‘South-West Columnar Chamber’ (4)**, mostly burnt, and in the south wall of the **‘South Terrace Basements’** where the mortises of the upper surface of a block can be seen as well as mason marks of a double axe with stem (Fig.5.17-5.18).

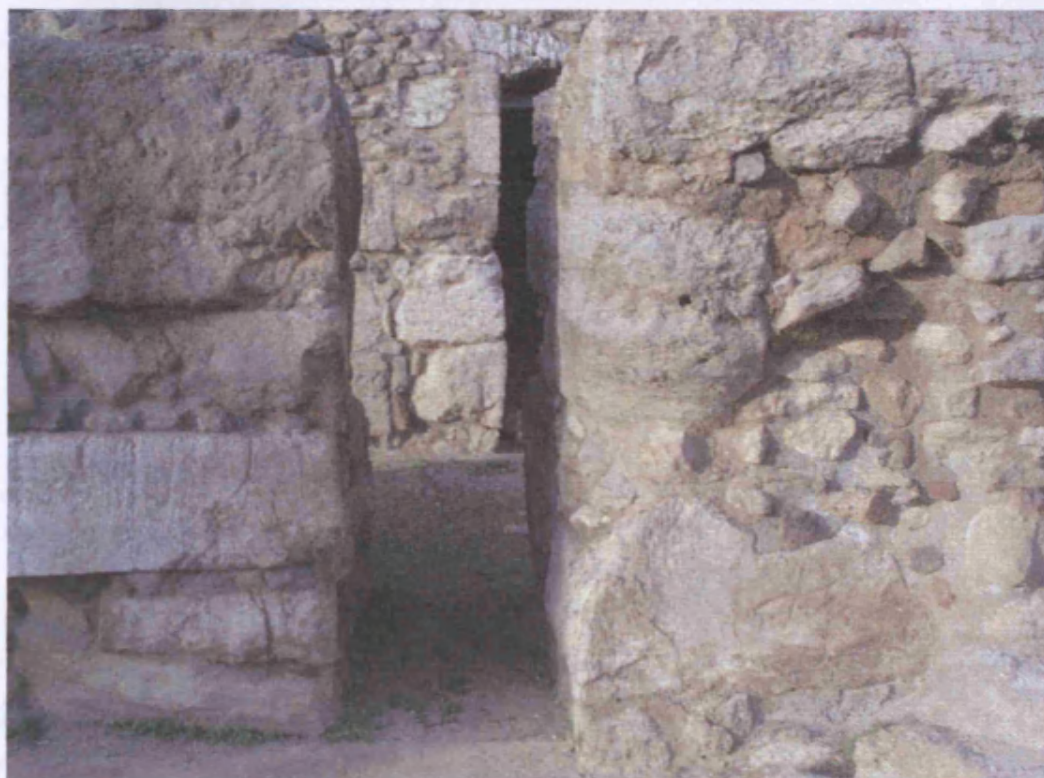
Fig. 5.18: gypsum blocks in secondary use on the other side of the wall shown above (notice double axe mason's mark on the right)

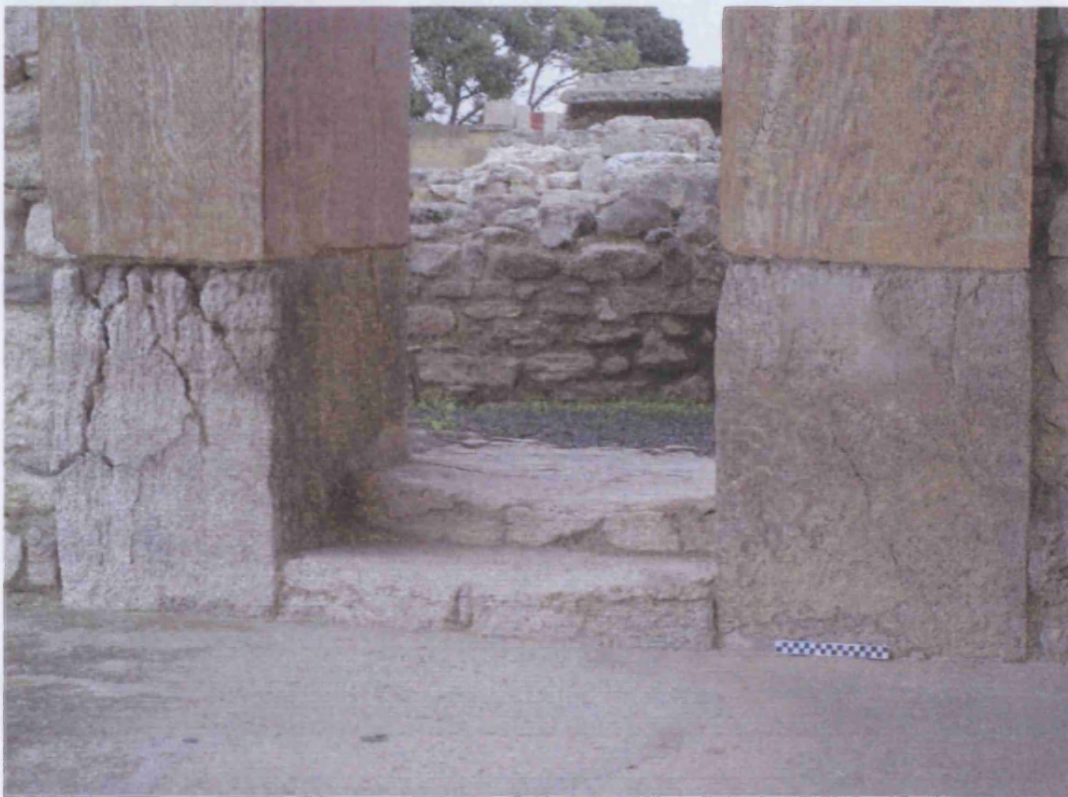
Fig. 5.19: north doorway of the South West Columnar Chamber (viewed from south)

The doorway was probably more of a passage, as indicated by the absence of the projections that would hold the wooden door as observed on the typical L-shaped doorjambs (Fig.5.19). The bases (which could also be called piers since they are not really doorjambs (*KN201* and *KN202*)), the treads of the two steps (*KN203* and *KN204*) and the adjusting threshold (*KN205*) are made of selenite. It is quite interesting that the crystals are used vertically on the piers and the threshold and horizontally on the steps (Fig.5.20). It seems that Minoans preferred the most reflective face of the stone for the front surface of orthostates, piers and doorjambs. Presumably the column base in the middle of the room as well as the jambs of the east doorway towards the 'South Propylaeum' would also be made of selenite but are now reconstructed in concrete.

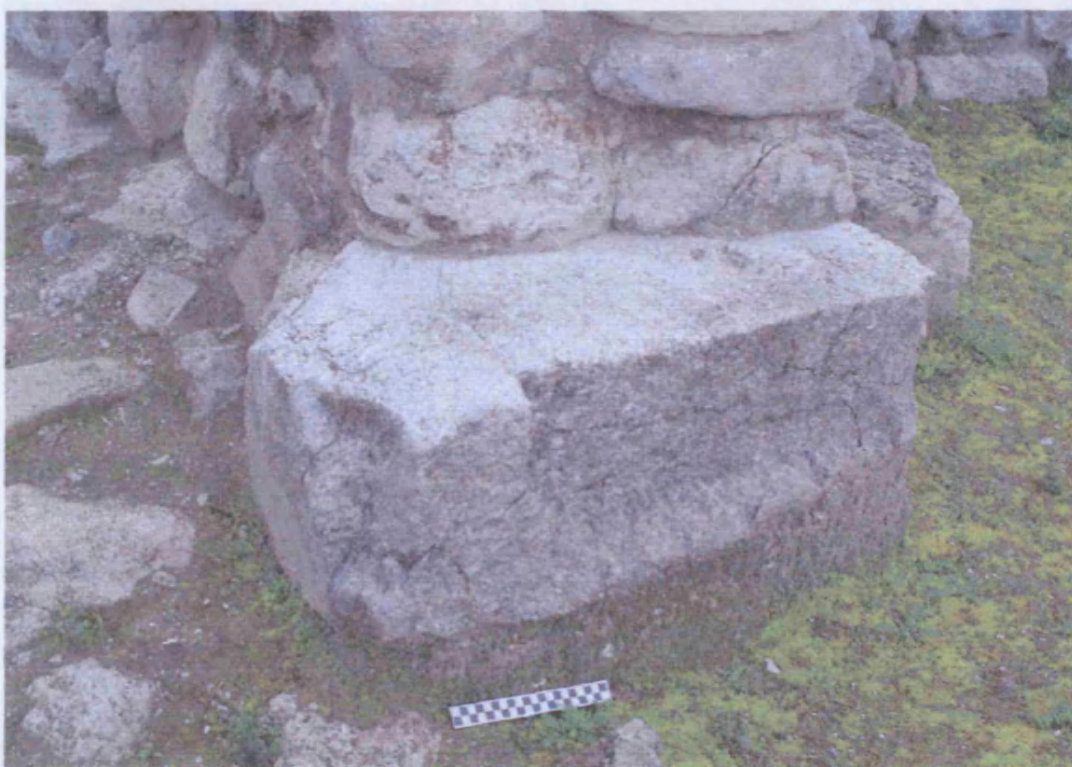
Fig. 5.22: selenite doorjamb base at the entrance of Magazine A (KN210)

At the entrance of **Magazine A (17)**, there is a selenite doorjamb (KN210), placed horizontally, with fire mark on the upper surface area that was in contact with the wooden frame of the door. The entire doorjamb is exposed and thus the whole base is visible, as extends under L-shaped part that of the doorjambs that we usually see above the ground. It is clear that the L or T-shaped doorjambs are in fact small rectangular gypsum blocks, of which only the upper part that projects above the ground was cut to the shape of the wooden frame that was placed above, provided also with one, two or four projections depending to the position of the doorjamb (Fig.5.22).

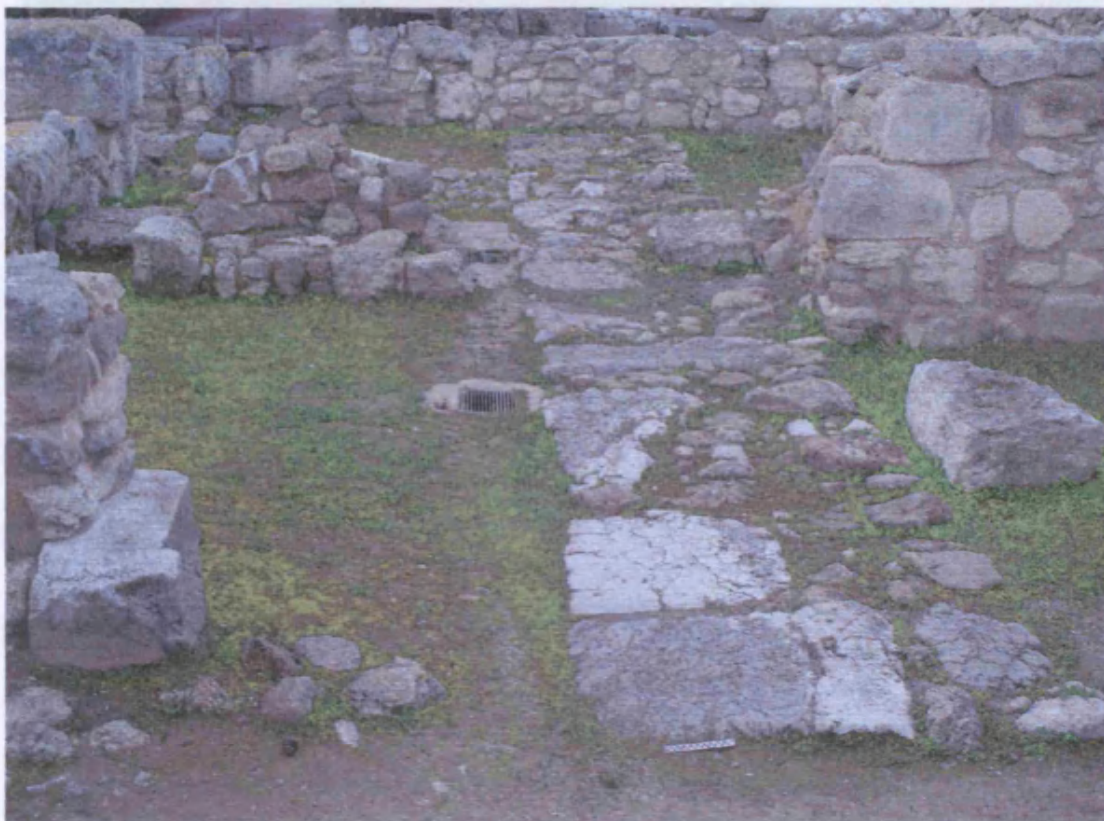
Fig. 5.23: selenite blocks in the wall between Magazines A and B (KN211-217)

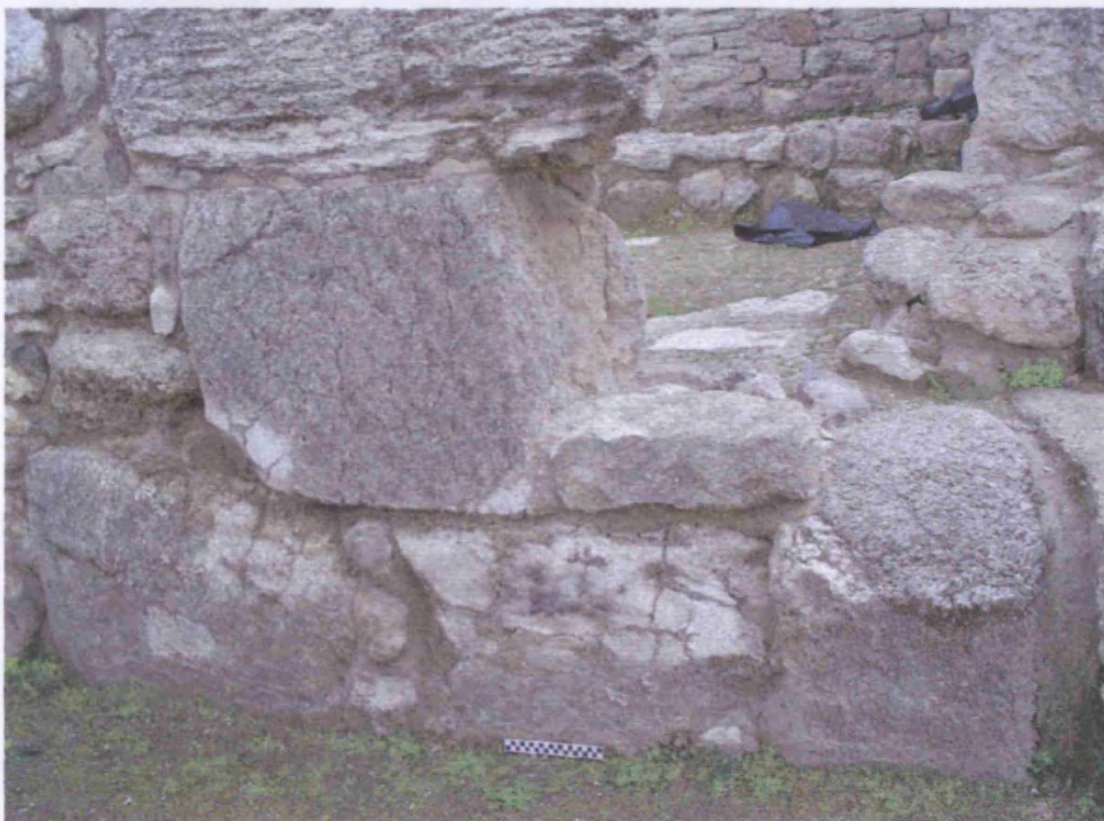
Fig. 5.24: selenite blocks built into the east wall of Magazine A

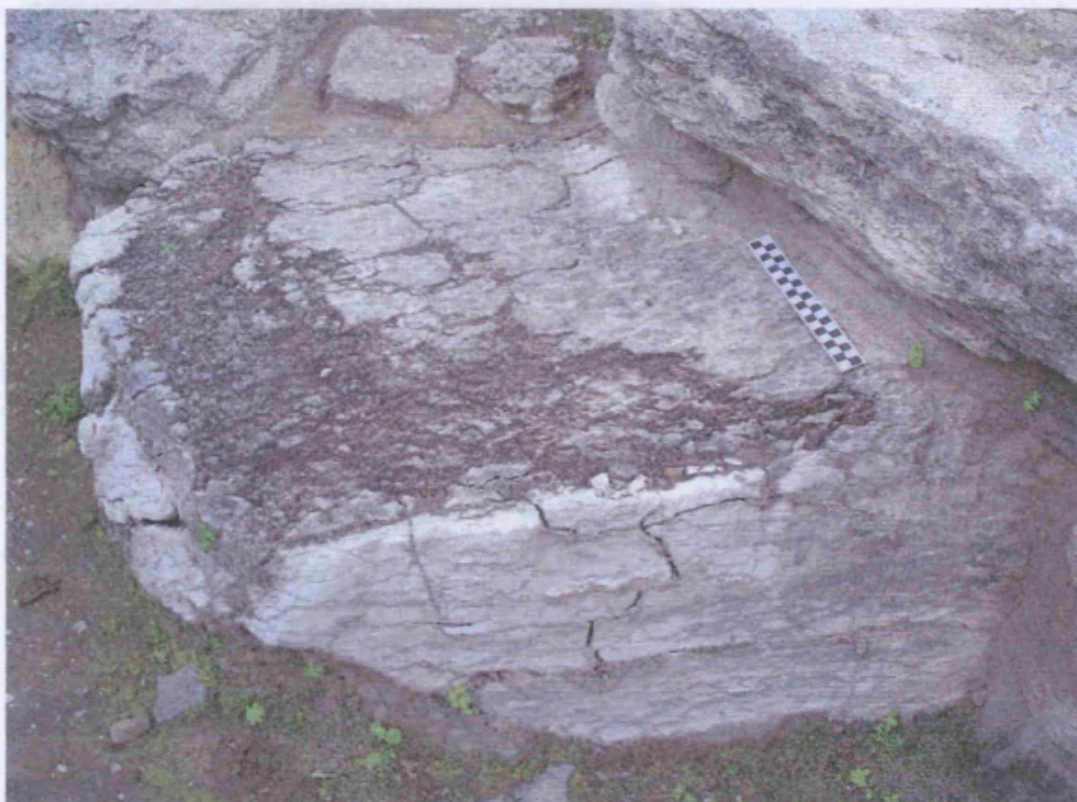
Fig. 5.25: nodular and lenticular gypsum block with parallel laminations in Magazine A (KN1718)

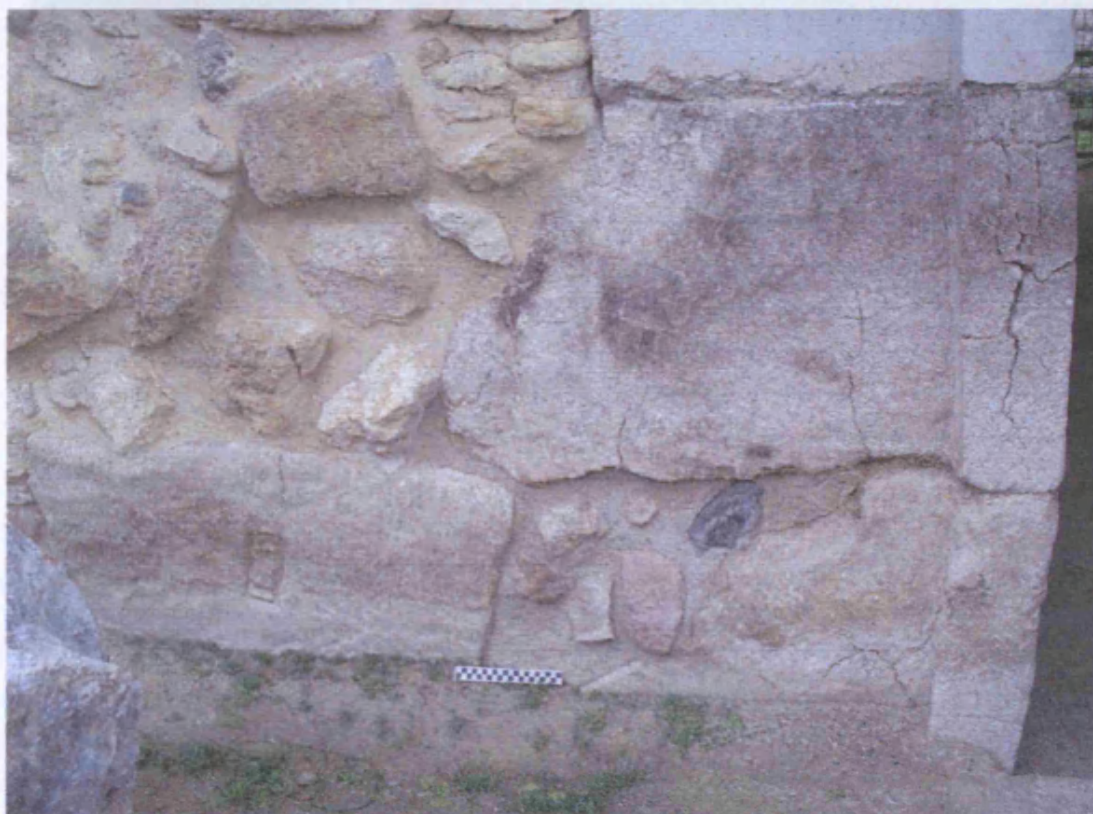
Fig. 5.26: reused block with mason's mark in north wall of Magazine A

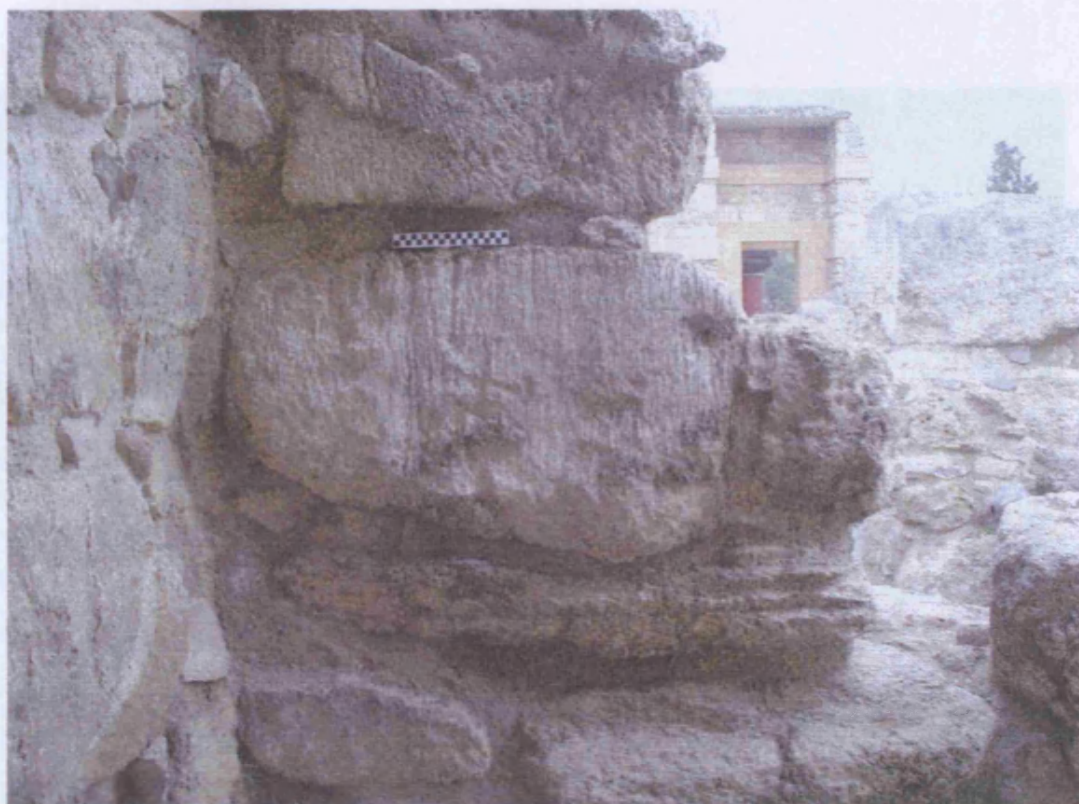
Fig. 5.27: *cross paté* mason's mark on south wall of the Corridor of the Stone Jambs
